## Dam Safety: Embankment Instabilities

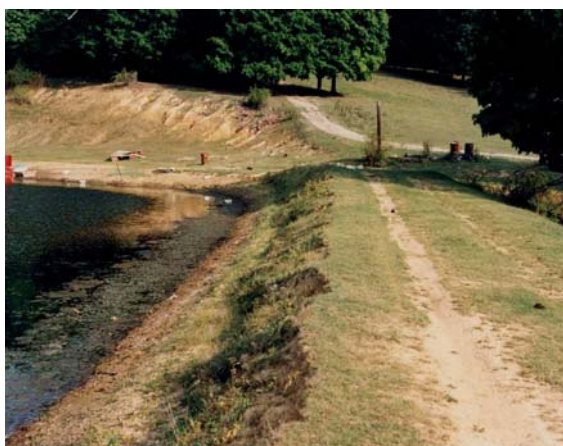
Figure 1 – Beaching

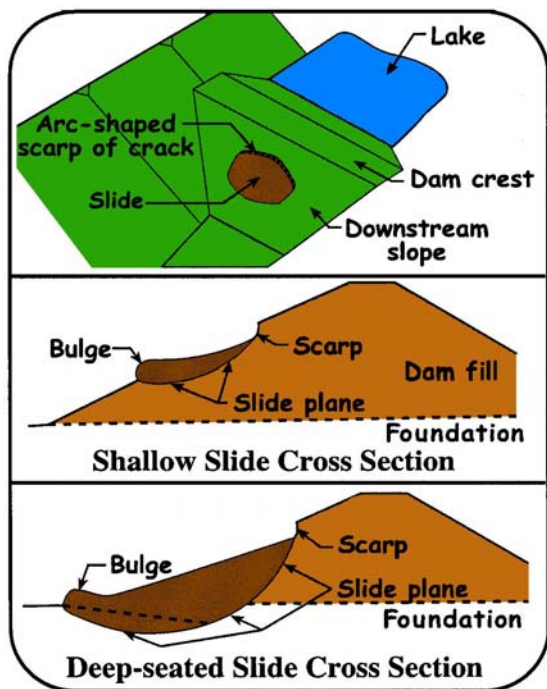
Figure 2 – Slide cross-sections

A slide in an embankment or in natural soil or rock is a mass movement of material. Some typical characteristics of a slide are an arc-shaped crack or scarp along the top and a bulge along the bottom of the slide (see drawing). Slides may develop because of poor soil compaction, the gradient of the slope being too steep for the embankment material, seepage, sudden
